SIO Shipyard Representative Bi-Weekly Progress Report		
Project: AGOR 28	Contract No.: N00014-12-C-0305	Shipyard: Dakota Creek Industries
Prepared by: Paul D. Bueren Scripps Institution of Oceanography (SIO) 297 Rosecrans St. San Diego, CA 98106	Date: August 28, 2014	Program Officer: Robert (Tim) Schnoor Office of Naval Research 875 Randolph St ONR 321 Arlington, VA 22203-1995
Distribution Statement A: Approved for public release; distribution unlimited.		Report No. A002.062

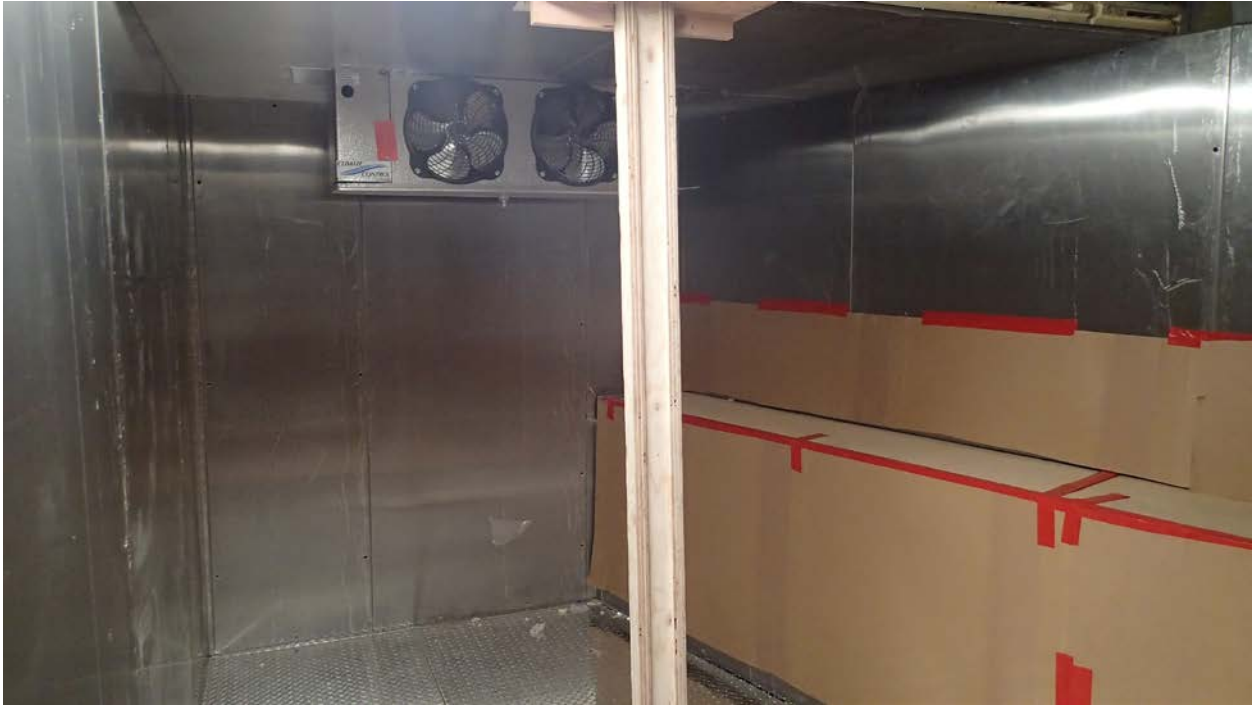
- Reefer Boxes – Modular panels are being installed, with the Chill Box at about 70% complete and the Freeze Box at 50%.

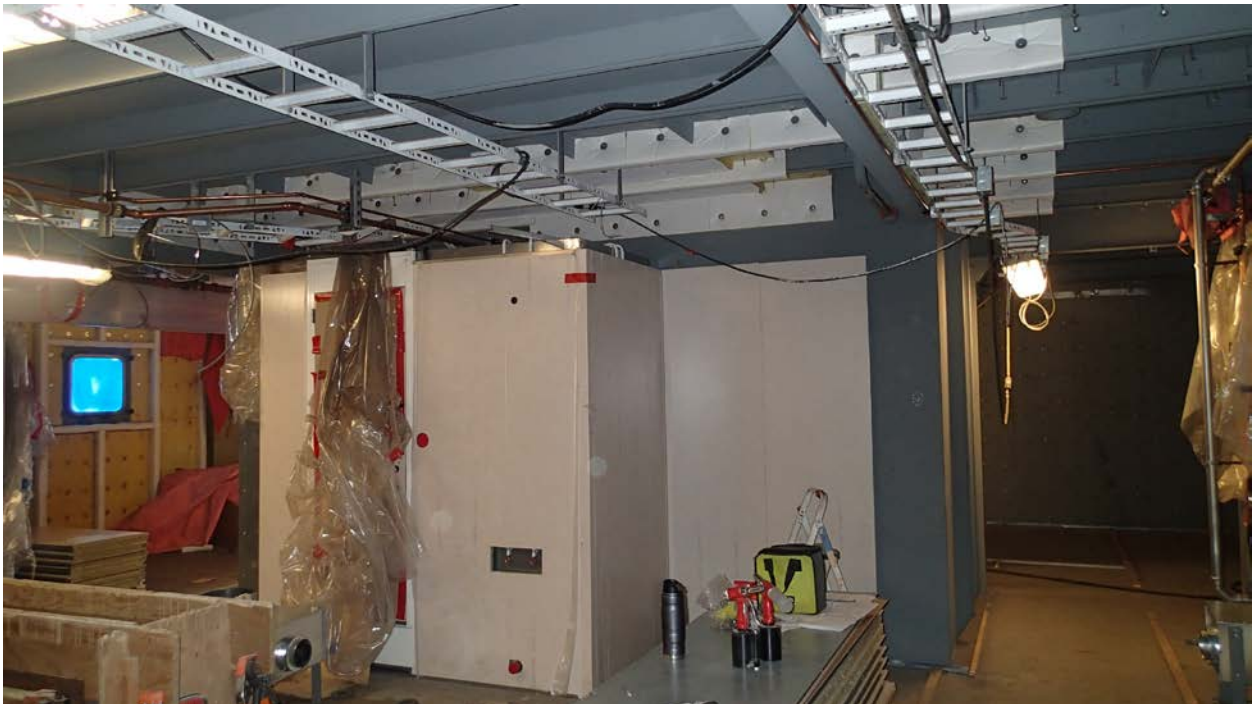
- Foc'sle Deck Joiner Work – Some joiner work is being installed around the heads only. The joiner work is being hampered by the lack of cable runs to these spaces. Note the empty cable trays.

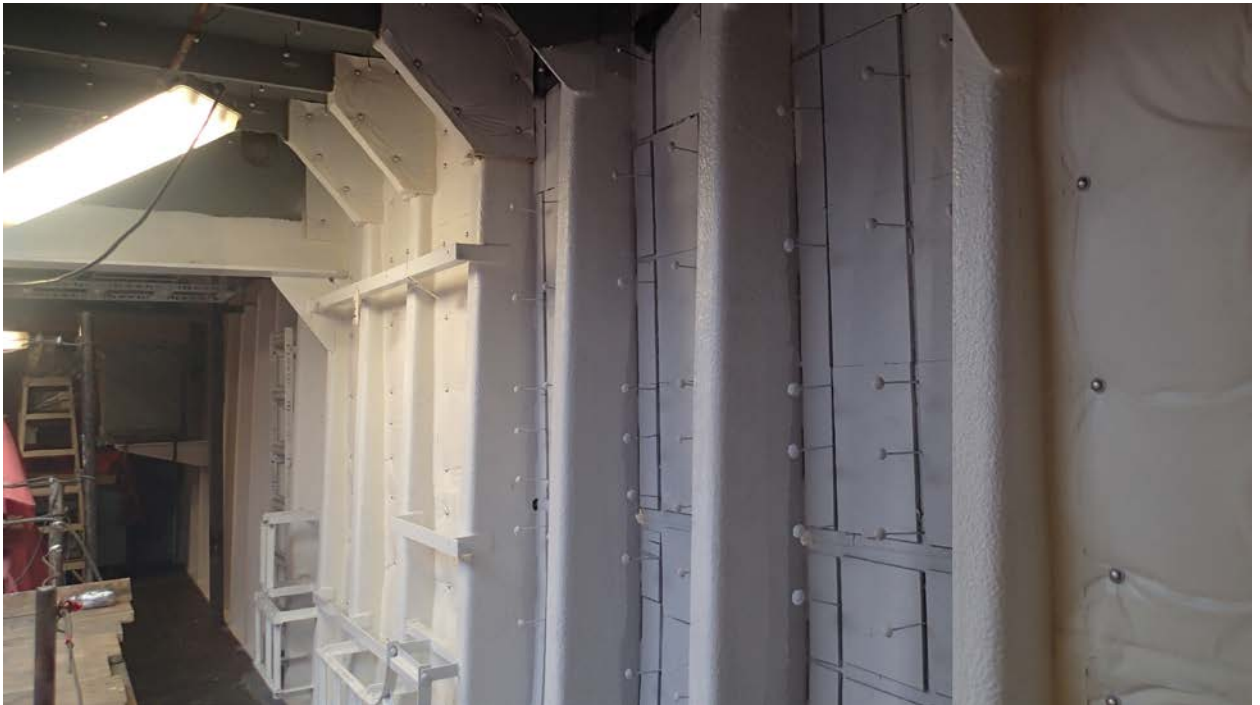
- Engine Room Tile – Tiling completed on port and starboard hull. Frames sprayed with Delta DT. No tiles have been installed on the tank tops at this time.

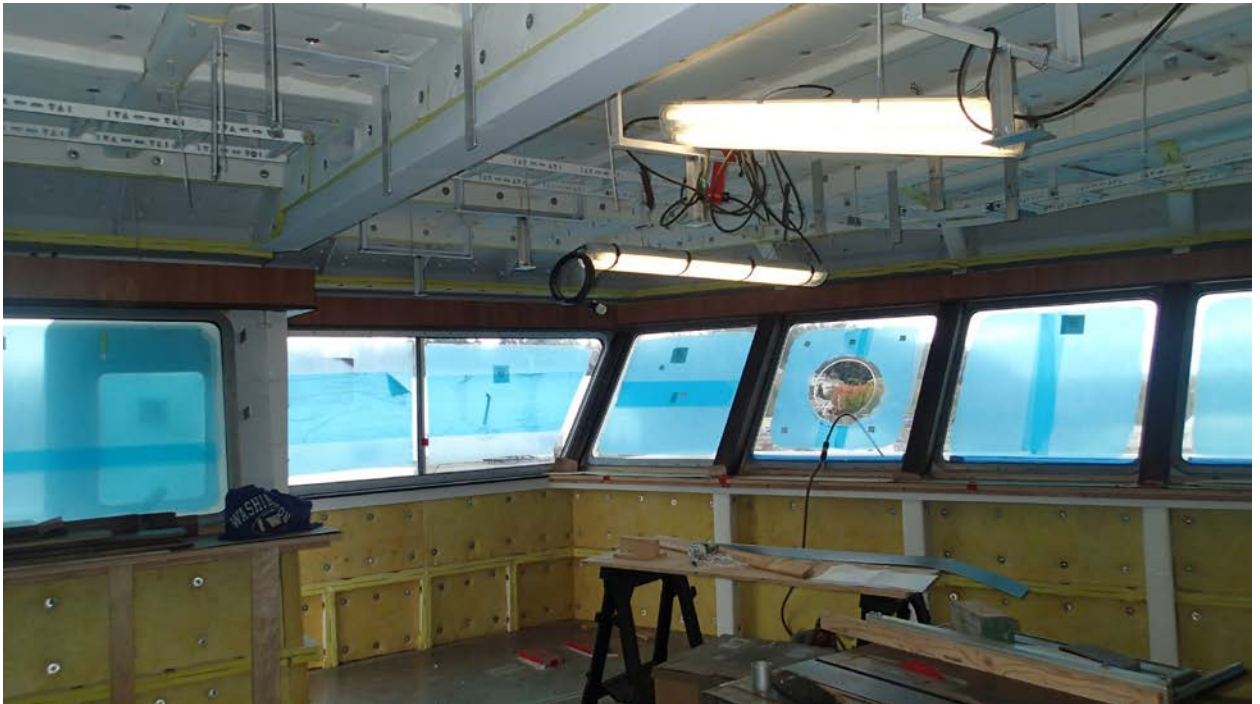
- Pilot House – Insulation nearing completion and Kelly the carpenter continues with the installation of the wood trim.

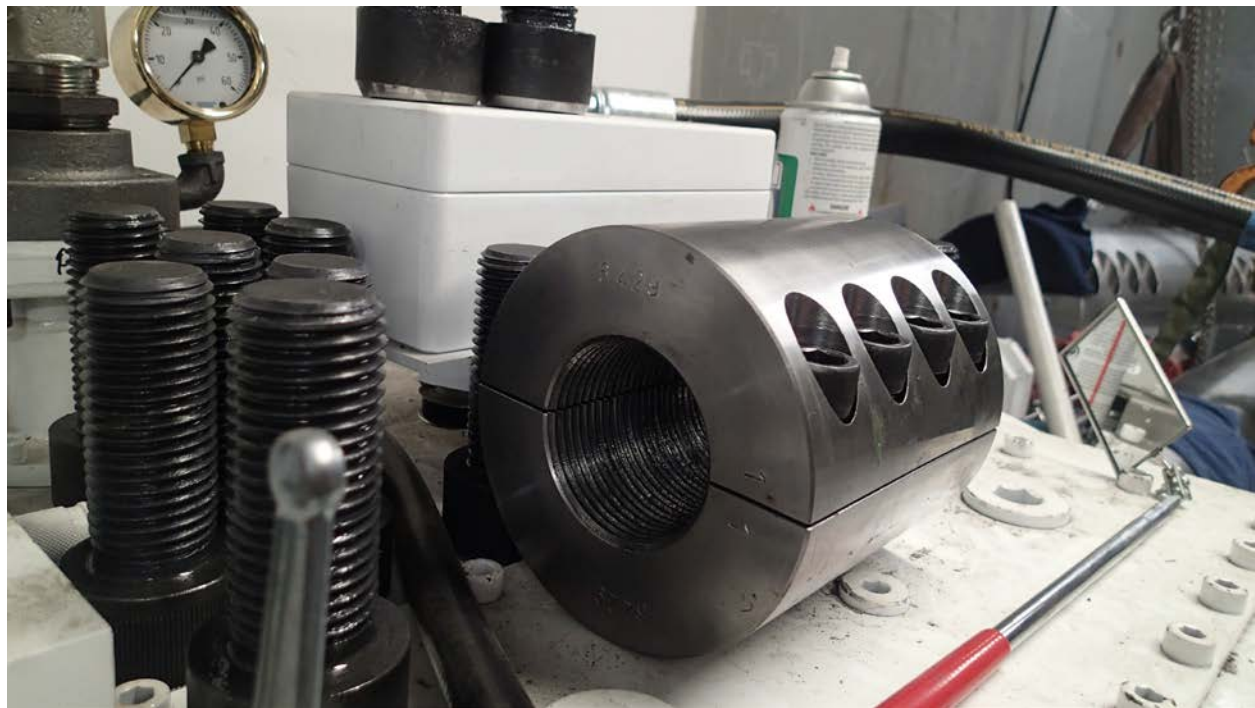
- Preliminary propulsion shaft alignment underway, port and starboard. Starboard Pitch Control Shaft and Nut shown below.

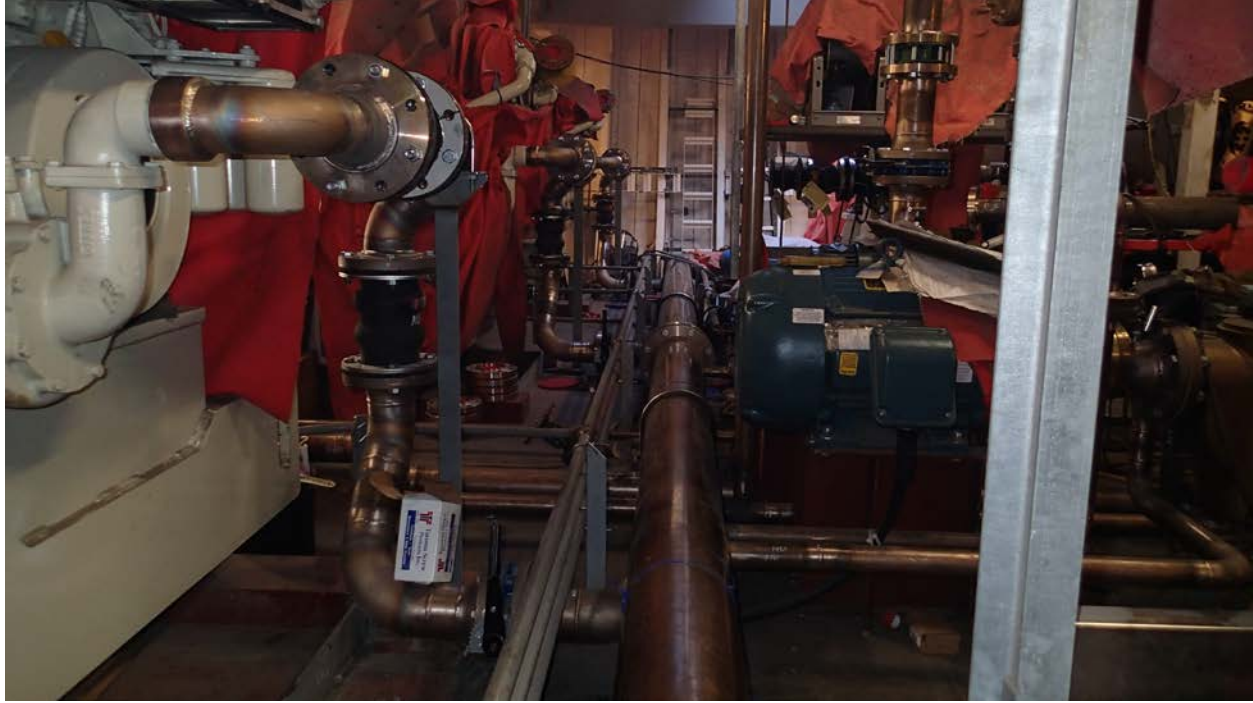
- Seawater Piping – Seawater supply to the engines is connected. Fitters working on the engine overboard piping runs.

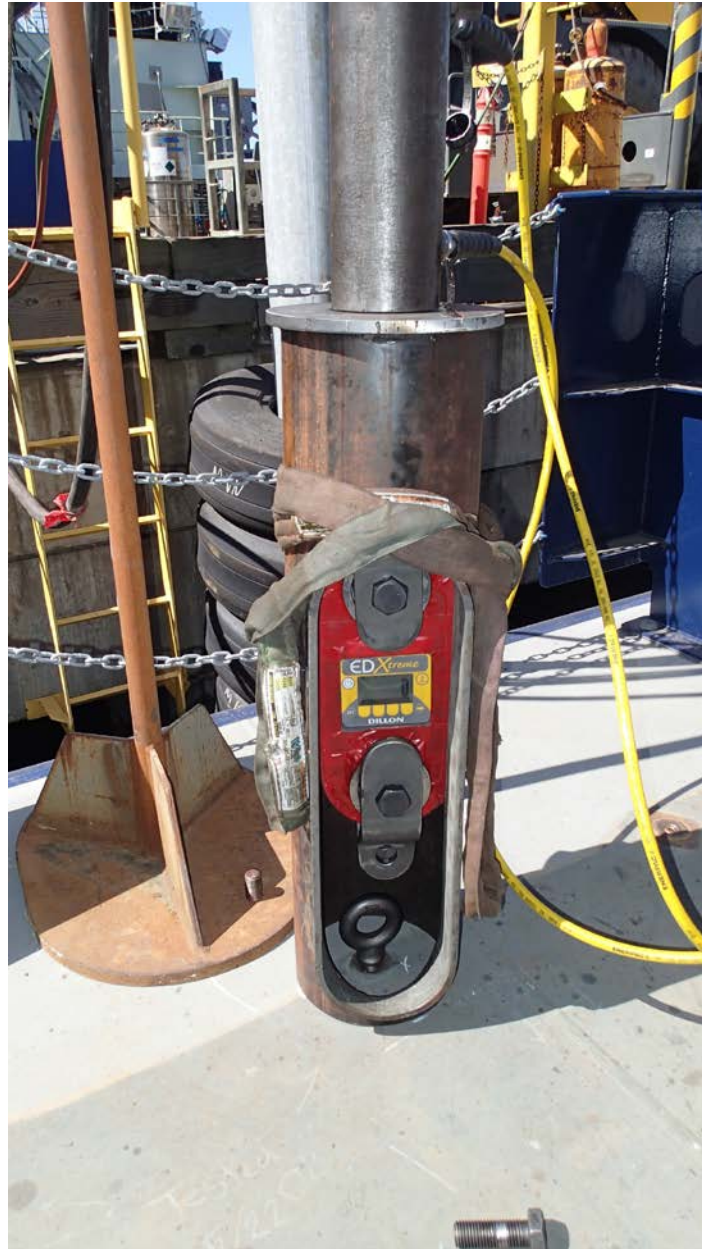
- Deck Sockets – 10% of the 820 1-inch deck sockets were tested to 7500-pounds in the vertical direction for 5-minutes. No failures were noted. All 82 tests were witnessed by a government representative. Thank you Cindy!
